Elliott Group C-10C Compressor Shell Distortion

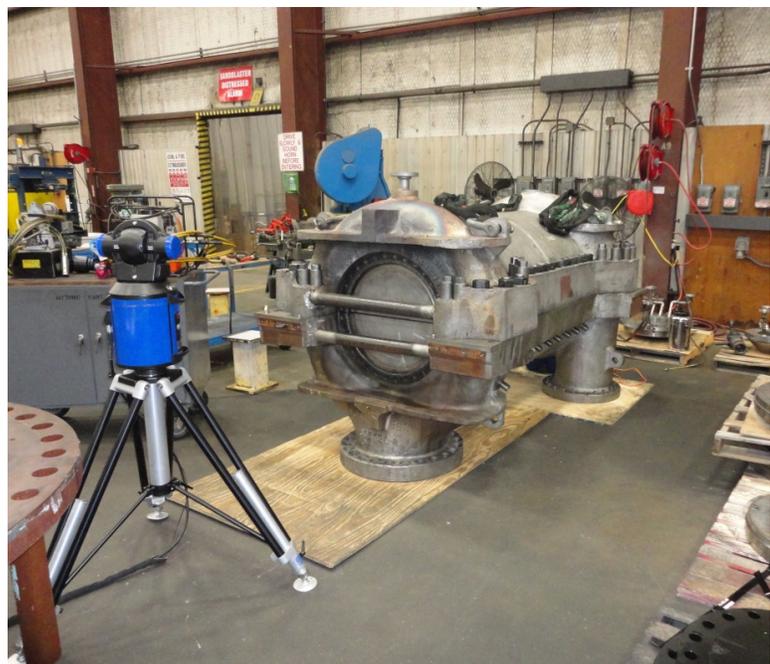
Elliott Group was performed a major overhaul on a 40-year-old C-10C compressor for Dow Chemical. The compressor had experienced shell distortion during its service life, resulting in undesirable loss of pressure. Elliot Turbo required metrology services to determine the flatness and bolt hole locations of the sealing end wall on the suction and discharge ends of the compressor.

ACQUIP Services were contacted and immediately traveled to the site equipped with a FARO laser tracker system to assess the problem and shell condition. Acquip alignment Engineers analyzed the parallelism and orientation of the case end walls in order to calculate the needed machining to bring the end walls within tolerances. The bolt hole positions were measured and mapped out in order to compare them to the provided CAD drawings and determine whether they were within tolerances. Utilizing this split line data, Acquip's service engineers were able to help set up the mill for the machining of the horizontal joint.

ACQUIP's experience and versatile laser tracker shortened the outage by quickly acquiring all the necessary data. The compressor was machined accordingly and heat treated to be placed back into service. ACQUIP was able to quickly respond and solve the problem, consequently saving time and resources during the outage process.
