## General Electric D11 Steam Turbine Internal Alignment Wansley GA.

### PROJECT SCOPE

The General Electric D11 steam turbine was brought down for a scheduled outage. GE power and water outage services required a top on tops off alignment of the High Pressure and Intermediate Pressure sections of the turbine. Laser was the preferred choice for alignment due to these units becoming notorious for their unpredictable shell reaction between major outages.

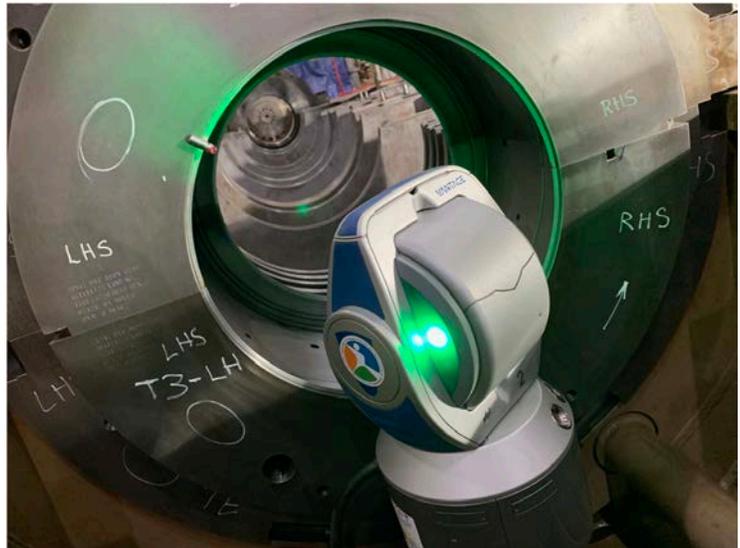
ACQUIP Services was contacted to perform a top on tops off alignment of the HP/IP section of the D11 Steam Turbine. ACQUIP utilized a FARO Laser Tracker system to measure and analyze the alignment data. From the acquired data the shell deflection and diaphragms adjustments were calculated. The data acquisition process was done while other work was being performed. Since the line of sight of the laser beam can be broken at any time without affecting the measurement accuracy, hence and optimizing the outage process.

ACQUIP's engineers' through a versatile laser tracking system and their sheer experience shortened the outage by quickly acquiring all the alignment readings. The alignment of the unit was restored the unit to its maximum performance, which resulting in a net gain in efficiency of approximately 4% once the unit was started. The rapid response and meticulous alignment done by ACQUIP, coupled with a state-of-the-art laser equipment, resulted in a fast turnaround and an increase in efficiency, which would improve the life of the unit as well as its profit margin.
